TRANSPORTATION RESEARCH CENTER

ON-SITE AIR BAG INVESTIGATION

CASE NO. - 96-11
FLEET - PRIVATE VEHICLE
LOCATION - PENNSYLVANIA
ACCIDENT DATE - [REDACTED], 1996

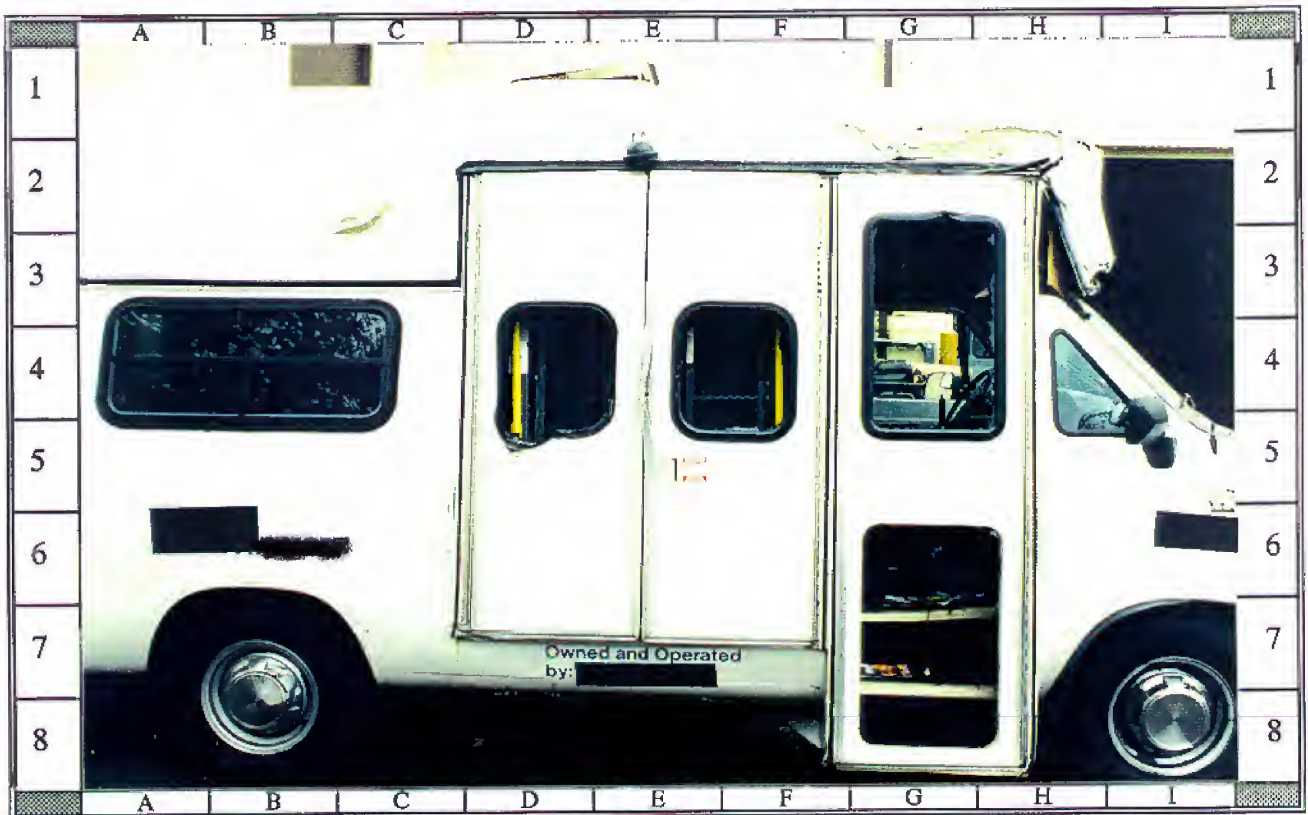
67: Vehicle #2's damaged right side viewed from right showing pole impact behind double doors, mailbox impact to double doors, and tree impact above single door

CRASH: According to the Police Accident Report, the scene evidence, the vehicle inspections, and the case vehicle drivers, the front of the case vehicle impacted the middle left of vehicle #2 causing the case vehicle's driver and right front passenger side supplemental restraint systems (air bags) to deploy. The front of the case vehicle underrode the left side of vehicle #2 causing both vehicles to rotate counterclockwise and travel toward the southwest corner of the intersection. Vehicle #2's counterclockwise rotation combined with the case vehicle's underide of its left side caused vehicle #2 to trip and roll over toward its right side. According to the scene evidence and the case vehicle's driver, the case vehicle rotated approximately 90 degrees counterclockwise after impact and came to rest, essentially in the intersection, heading south. According to the Police Accident Report, the scene evidence, and vehicle #2's driver, vehicle #2 struck during the rollover a traffic control signal pole (see **SELECTED PHOTOGRAPHS #67**) as well

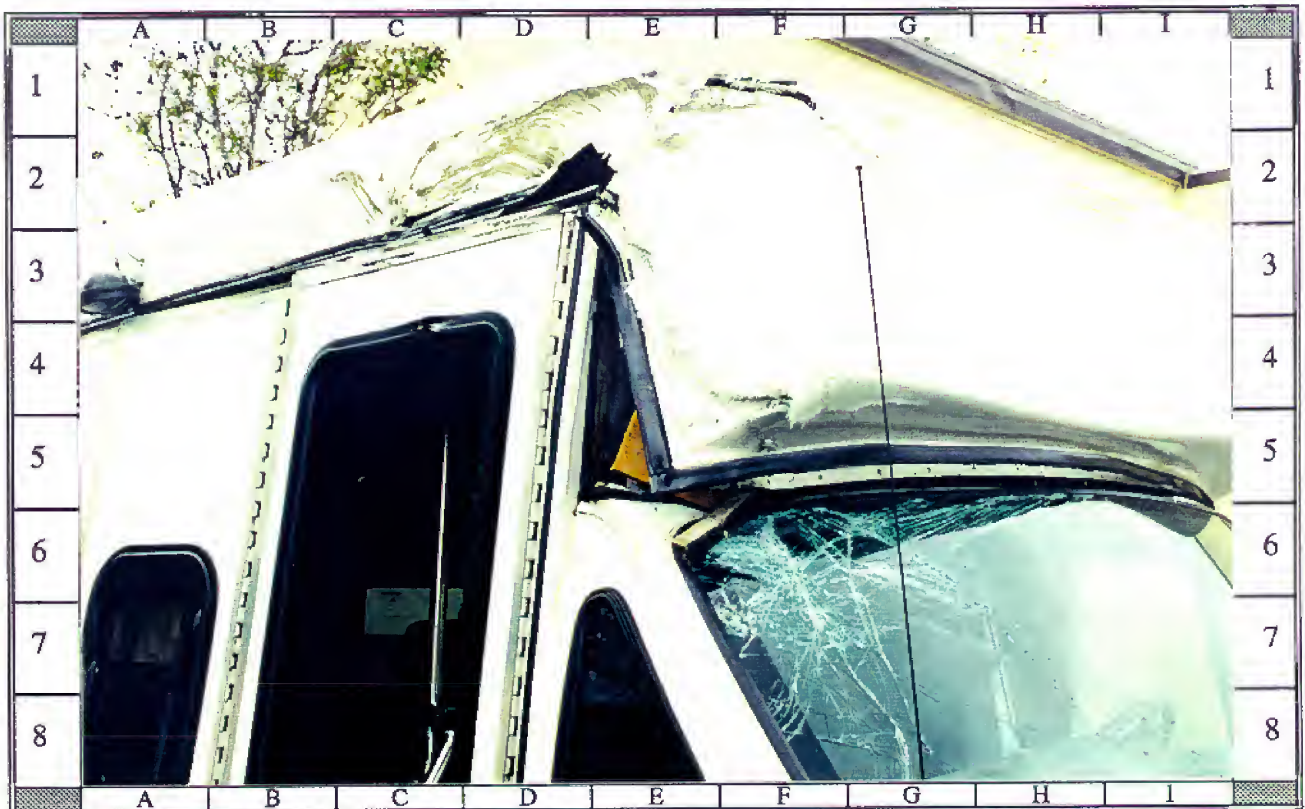
69: Close-up of Vehicle #2's right front roof and windshield damage from striking tree during rollover

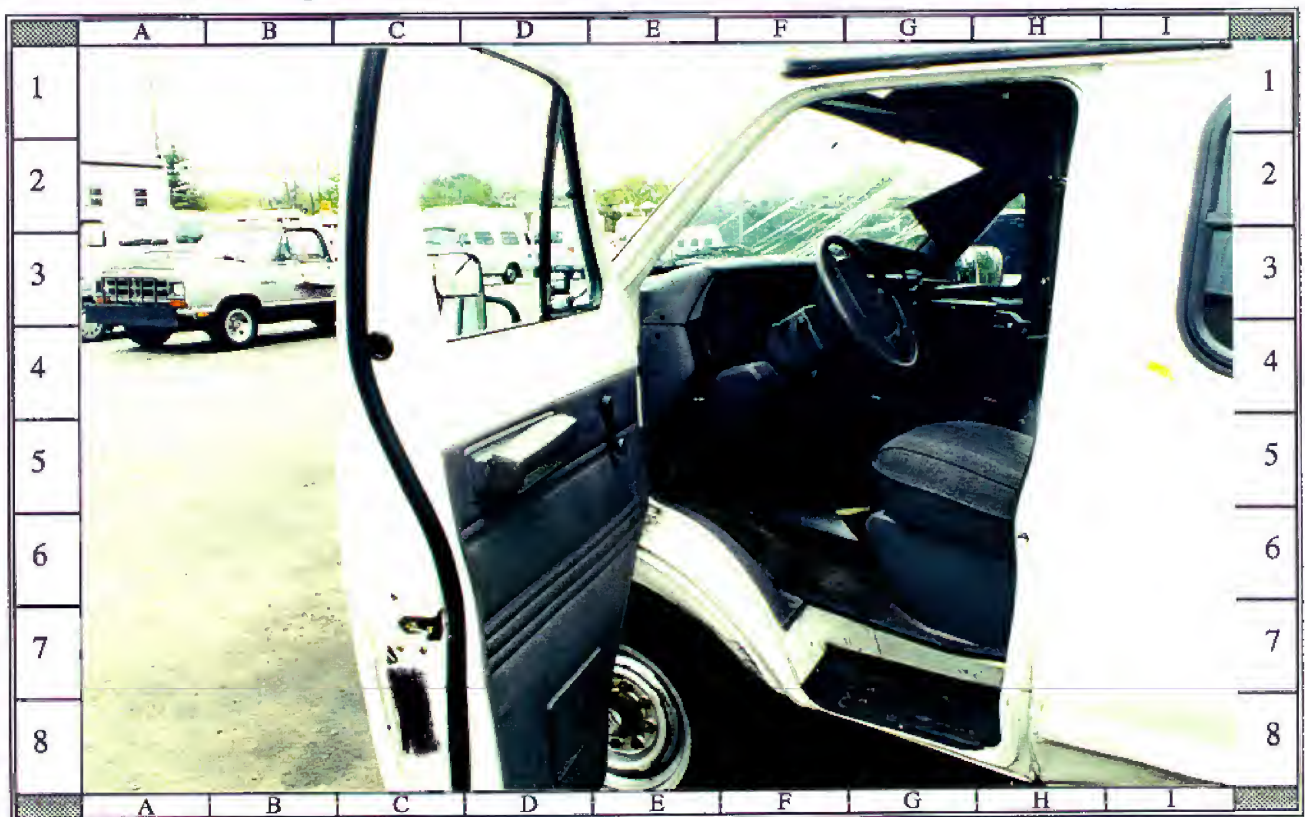
70: Vehicle #2's driver seating area and interior surface of driver's door; NOTE: no evidence of contact to door surface or steering wheel

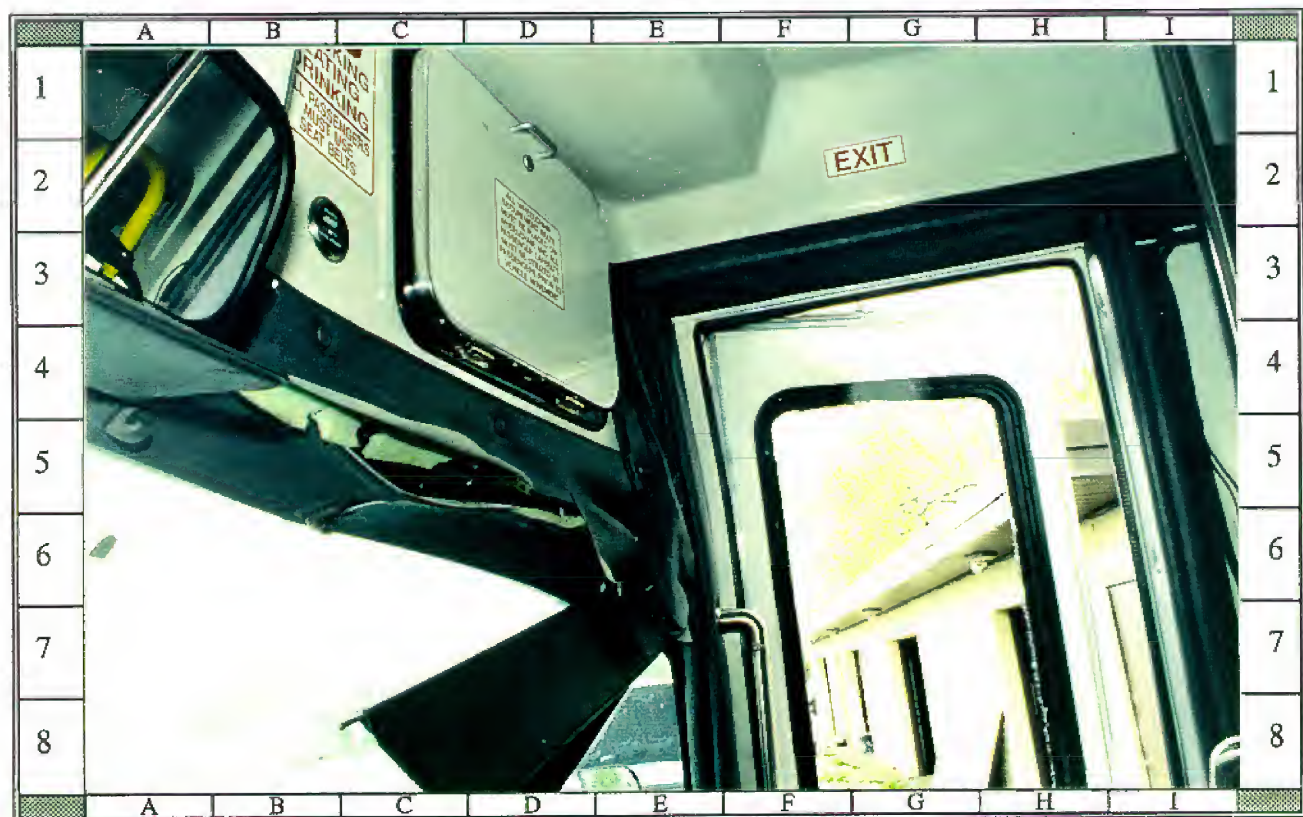
78: Vehicle #2's damaged front right overhead area near single right front door; NOTE: this is also the driver's final rest area
